FIRE INCIDENT STUDY
NATIONAL SMOKE DETECTOR
PROJECT

JANUARY 1995

LINDA E. SMITH, EPHA
DIRECTORATE FOR EPIDEMIOLOGY
U.S. CONSUMER PRODUCT SAFETY COMMISSION
4330 EAST WEST HIGHWAY
BETHESDA, MD 20814

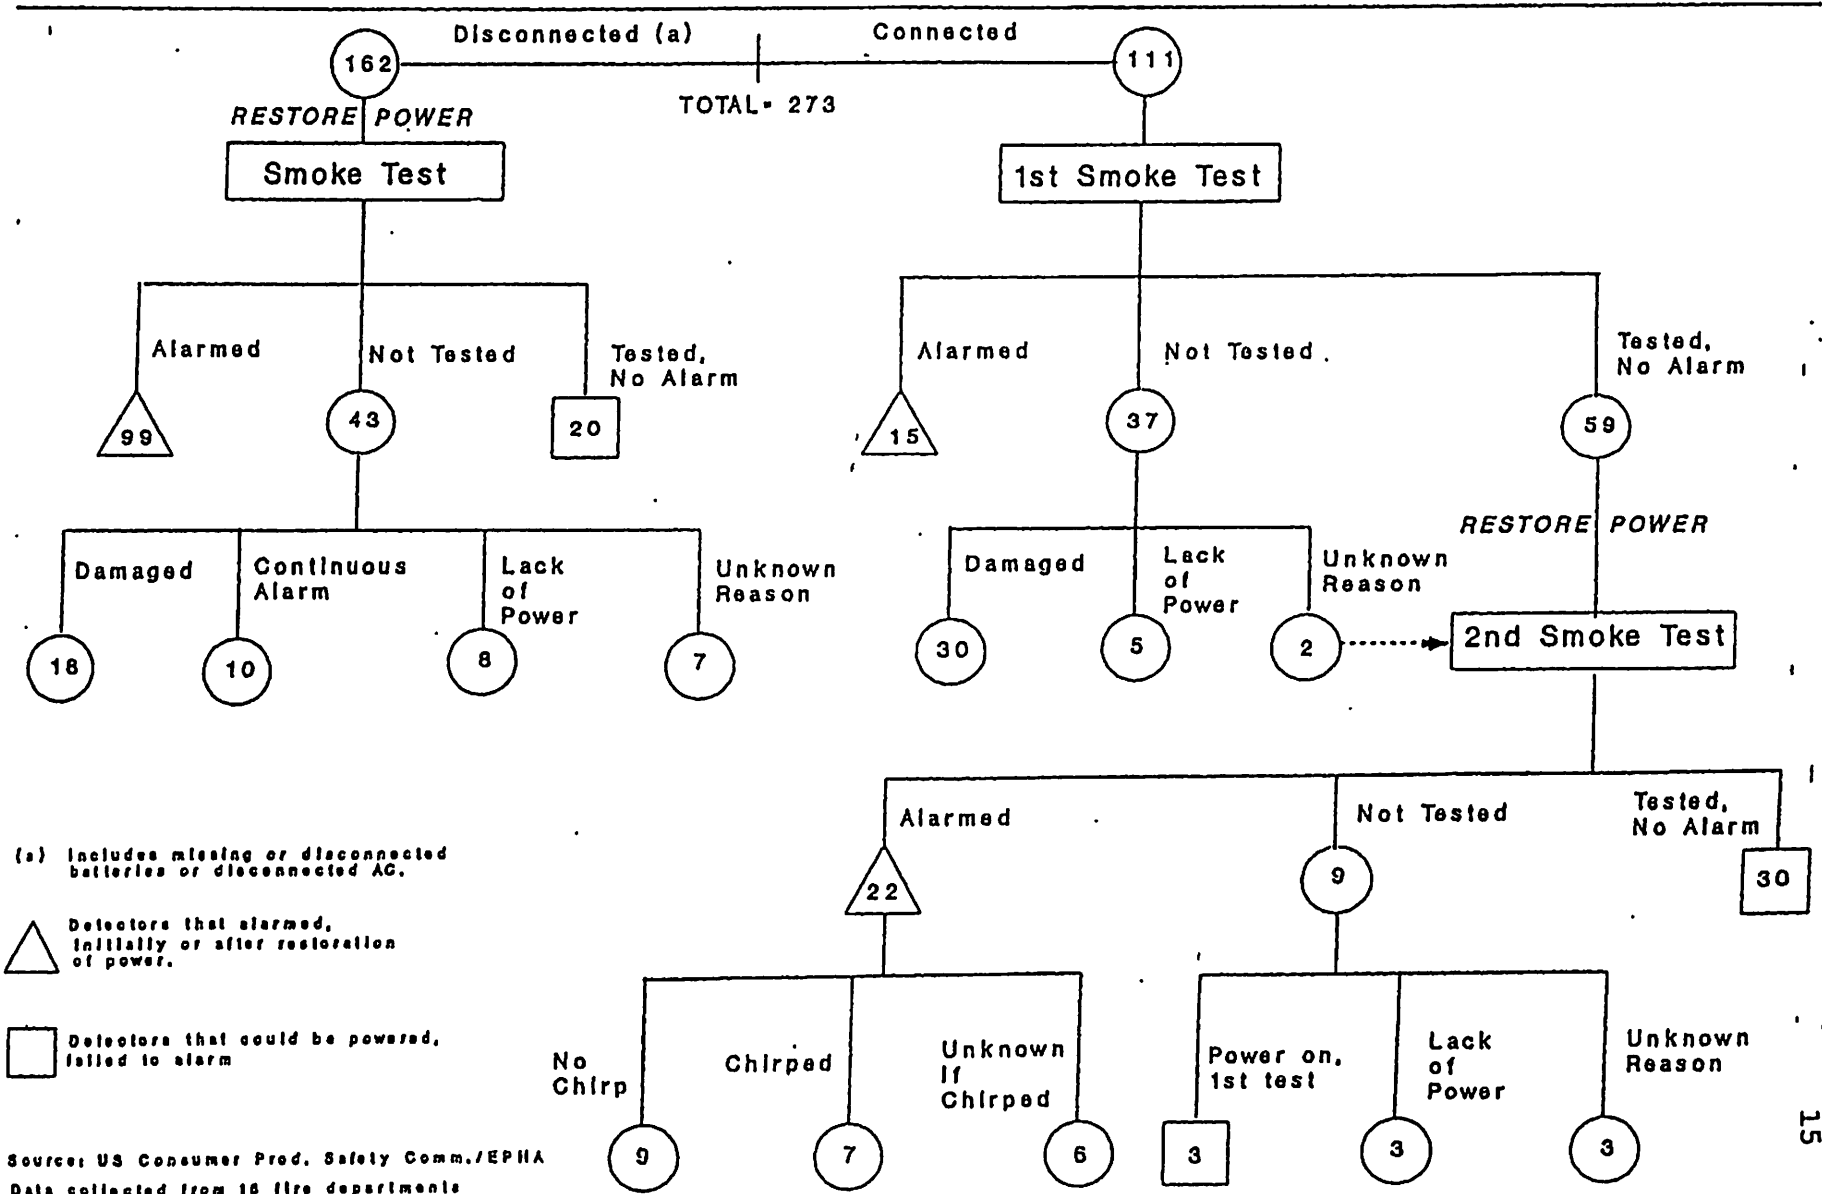
Figure 4

Fire Incident Study Smoke Test Results Detectors That Should Have Alarmed

restored. A total of 53 detectors (19 percent) failed to alarm to the smoke test even after power was restored. A total of 84 (31 percent) could not be tested under conditions of a connected power source, predominantly due to damage from the fire. Of these 84, 10 could not be tested because they alarmed continuously when repowered. A total of 189 detectors were tested with aerosol smoke during the testing procedure. Among those that were tested, 72 percent alarmed to the smoke test; 28 percent did not alarm.

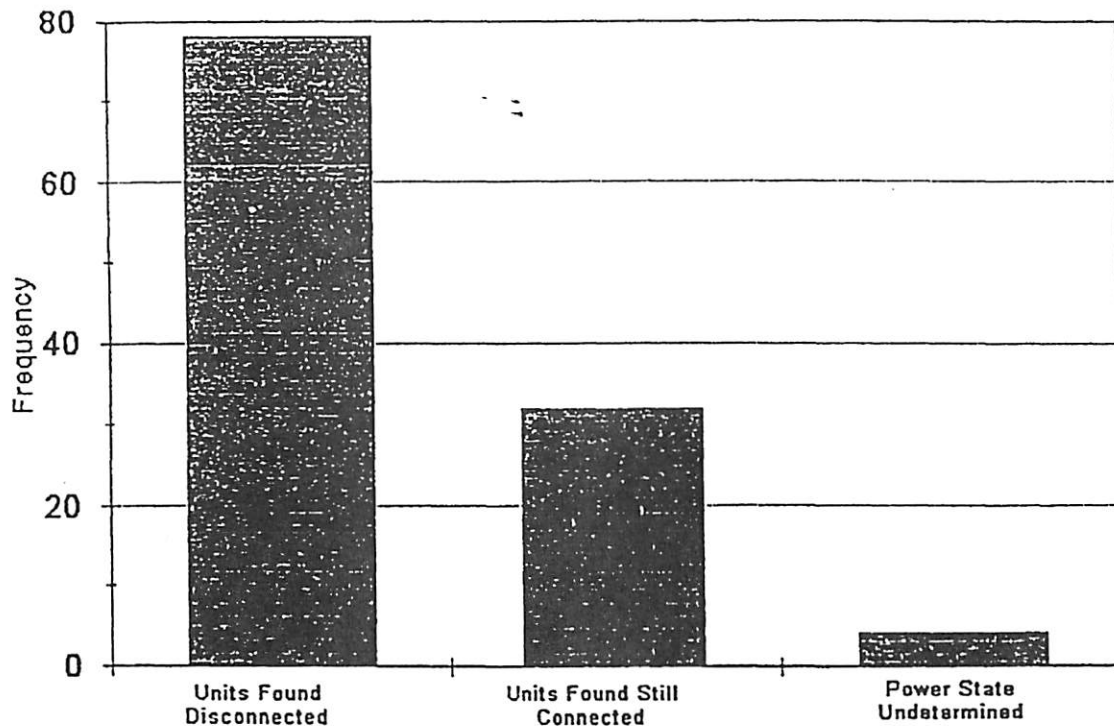
Figure 1. Power state of smoke detectors.

The results of the laboratory testing are divided by the detector's power state: units that were found disconnected after the fire, units that were found still connected after the fire, and units for which the power state at the time of the fire could not be determined. These categories are displayed in Figure 1.

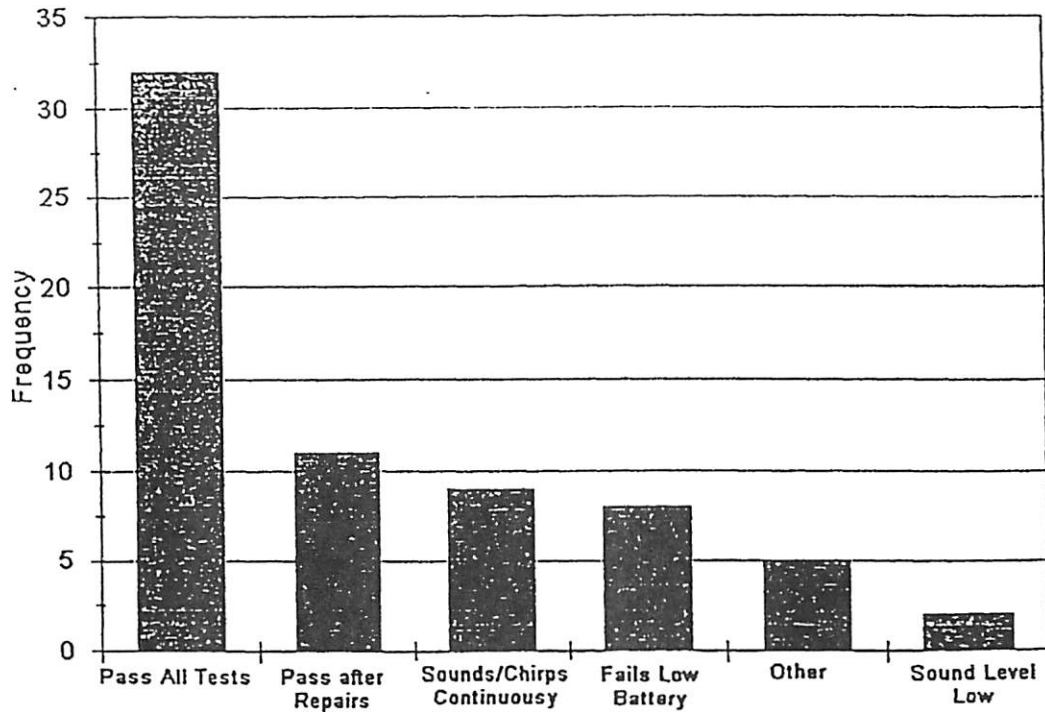
Figure 2. Laboratory results of detectors found disconnected after the fire.

Seventy-eight smoke detectors collected by fire personnel were found disconnected after the fire. Ten of these units had extensive fire damage, and no further testing was performed by the Engineering Laboratory. The remaining 68 detectors were examined, and the results are shown in Figure 2.

Thirty-three of the units passed all screening tests satisfactorily in the Engineering Laboratory. An additional 11 units were repaired in the laboratory and passed all retests satisfactorily. These repairs included:

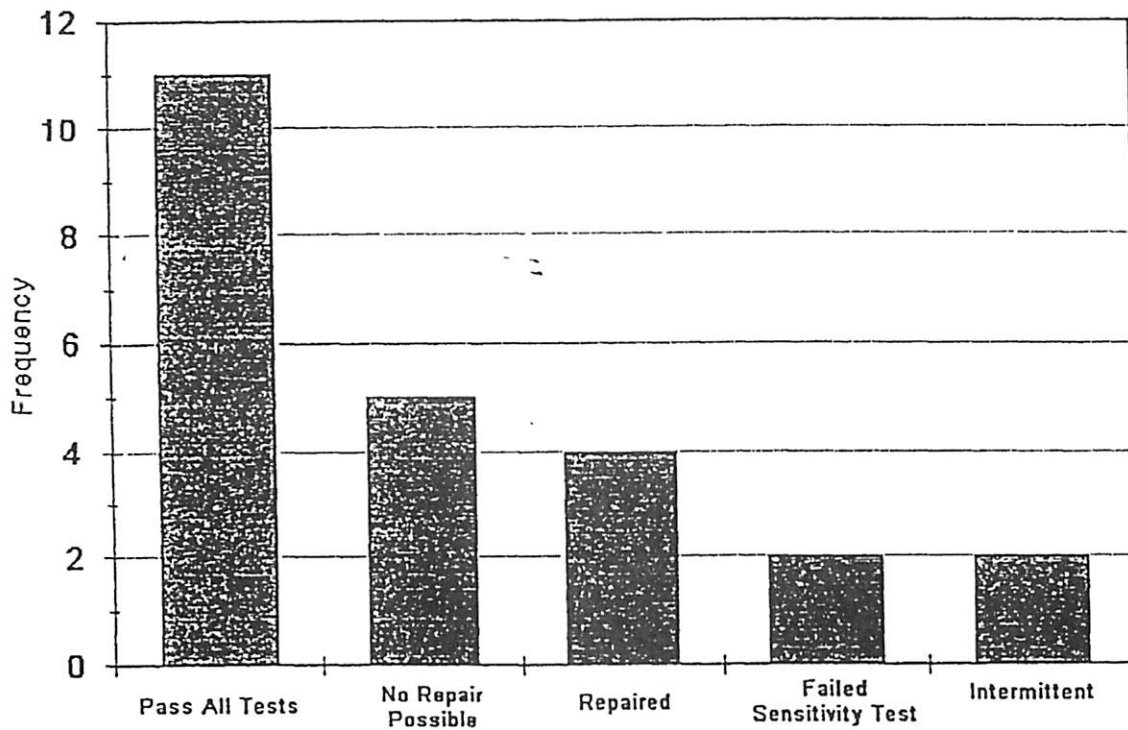
Figure 3. Laboratory results for smoke detectors found connected after the fire.

Thirty-two units were found with power connected after the fire; however, no one heard the alarm sound during the fire. Laboratory testing could not be performed on eight of the units received due to extensive fire damage. Test results for the remaining 24 units are summarized in the five categories below.

Ten smoke detectors passed all the tests outlined in Table 1 in the laboratory; an additional unit passed the testing protocol after handling. Handling the smoke detector in the laboratory may have restored continuity to a contact in the unit, resulting in a functional detector.

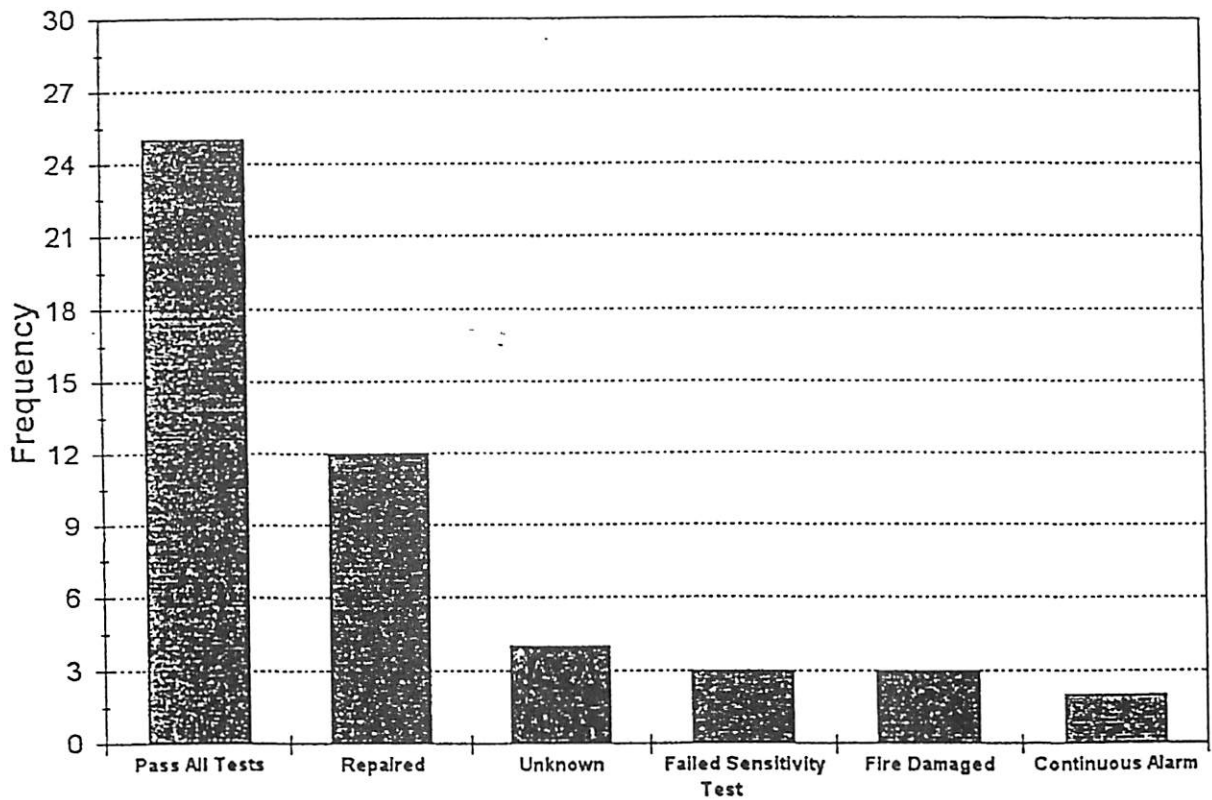
Figure 4. Laboratory results for smoke detectors collected for failing field testing.

Twenty-five of these units were able to pass the testing protocol in the

laboratory without any repairs. One possible reason other than excessive debris in the detector and the uncertainty of the power state of the detector is horn corrosion. Horn corrosion has been shown to account for detector failure [1]. The suspected detectors use a piezoelectric disk with three plated areas, typically made of silver, for the horn. Laboratory examination showed visible deterioration and corrosion on each of the horn contacts. Over time, the detector may become inoperative because the plated area in the horn element corrodes in the household environment. With corrosion and deterioration, the normally low electrical resistance of the pressure contact becomes higher until the horn can not sound an alarm signal.

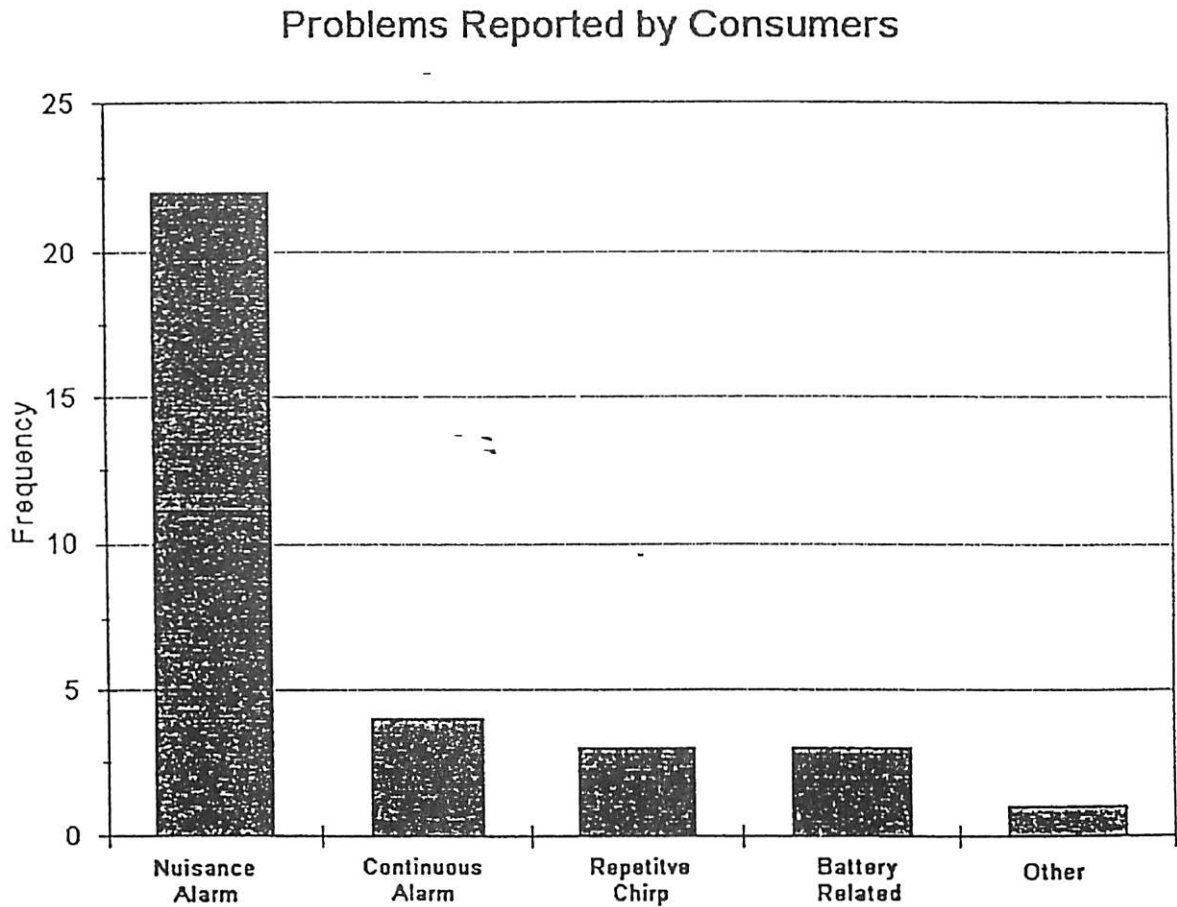
Figure 5. Problems with detector reported by consumers.

If the smoke detector had a disconnected power source, fire department personnel asked the consumer if they had a problem with the detector. Thirty-three smoke detectors were collected because of complaints, which are displayed in Figure 5.

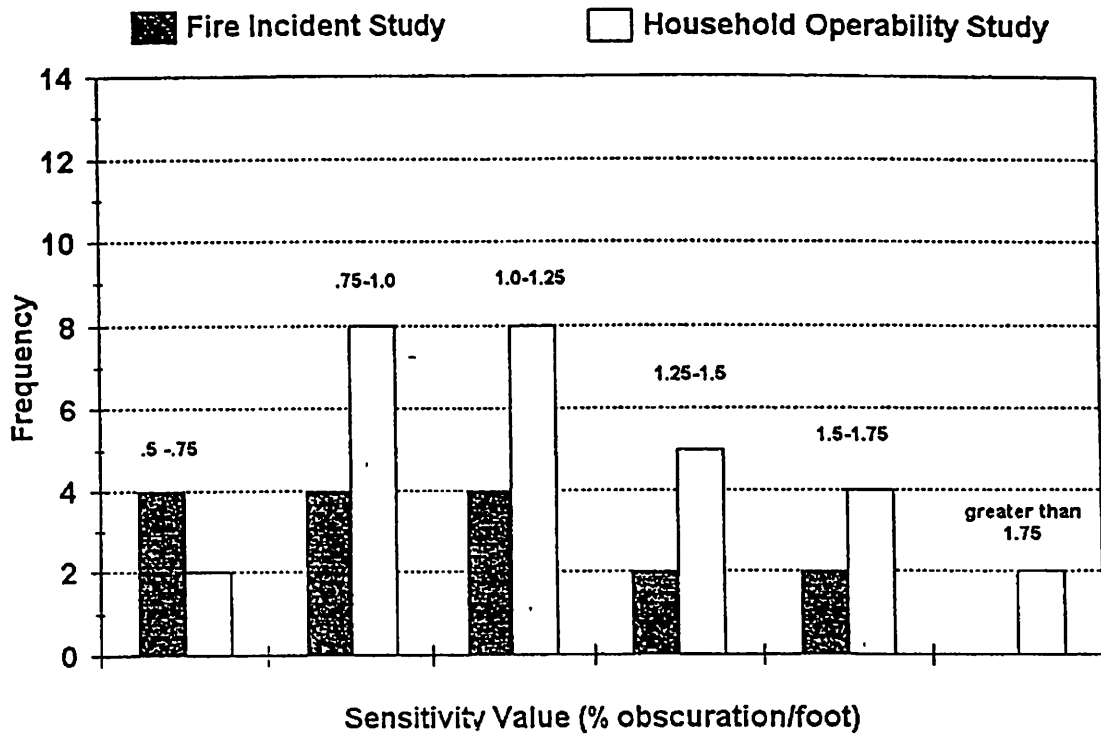
Figure 6. Sensitivity values of smoke detectors collected with which consumers complained of nuisance alarm problems.

Excessive dirt, dust and insect infestation can alter the sensitivity of the detector, causing an unusual number of nuisance alarms. The additional elements from the fire (e.g. soot, heat, and water) can adversely affect the detector's sensitivity. Thus, limited conclusions can be drawn from the information. An accurate assessment of the sensitivity values for detectors collected in the Fire Incident Study cannot be made since the condition of the unit before the fire is unknown.
