# Smoke Detector Operability Survey

## Engineering Laboratory Analysis

October 1994  
REVISED

Julie I. Shapiro  
U.S. Consumer Product Safety Commission  
Directorate for Engineering Sciences  
Division of Engineering Laboratory

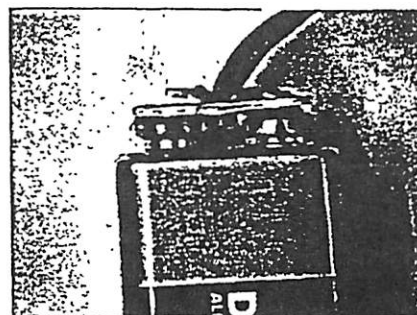
In three detectors, battery terminal contacts were loose. Two of these detectors failed the Low-Battery Alarm Test, but otherwise they functioned properly. In two additional detectors, corrosion was found on the battery terminals. One of these detectors failed the Low-Battery Alarm Test. The other functioned properly. Another detector did not originally respond because the negative battery terminal (see Figure 9) had a cold solder joint to the battery connector that came loose. The unit functioned properly after repair.

Figure 9. Cold solder joint.
