# Smoke Detector Operability Survey

## Engineering Laboratory Analysis

October 1994  
REVISED

Julie I. Shapiro  
U.S. Consumer Product Safety Commission  
Directorate for Engineering Sciences  
Division of Engineering Laboratory

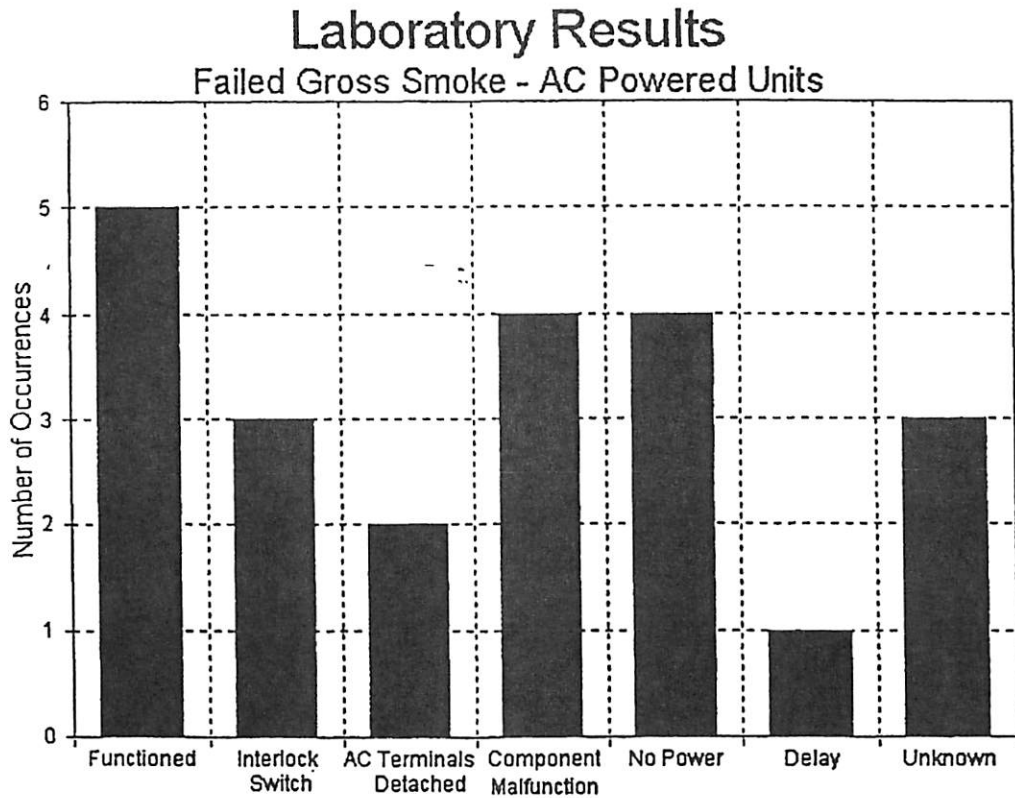
- Three units were missing covers, which made them inoperative because of an interlock switch that activated the detector when its cover was in place.  
In the laboratory, using the appropriate covers, one detector was operable and two sounded continuously. After a thorough cleaning of the detectors that sound continuously, one behaved appropriately, and one continued to alarm. Further investigation of the latter sample is required.
- Two units' AC input terminals were intentionally detached from the circuit board.  
Both detectors functioned properly and passed all tests satisfactorily after reconnecting the input wires.

Figure 2. Laboratory Results for AC Powered Detectors Collected for Simulated Smoke Test Failure (n=22).

- Four units had defective components.

The capacitor in the fourth sample failed, inhibiting power to the unit. The detector was not repaired and consequently could not be retested.

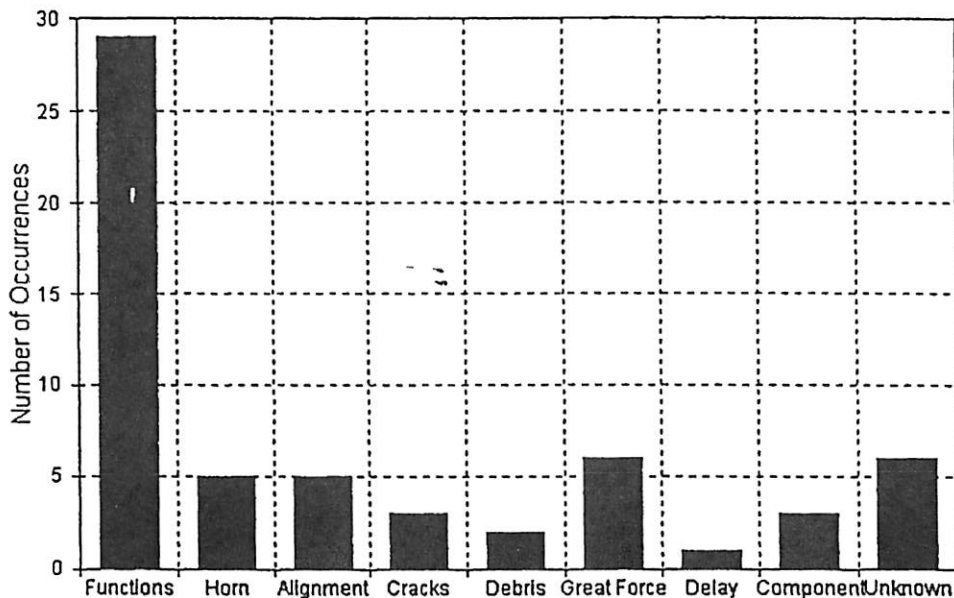
Figure 4. Laboratory Results for Detectors Collected for Test Button Test Failure (n=60).

The remaining 31 cases divide into eight categories involving horn contact deterioration, electrical component failure, physical flaws, test button contact difficulty, and other complications. The reasons for failure of the Test Button Test are summarized in Figure 4 and described below.

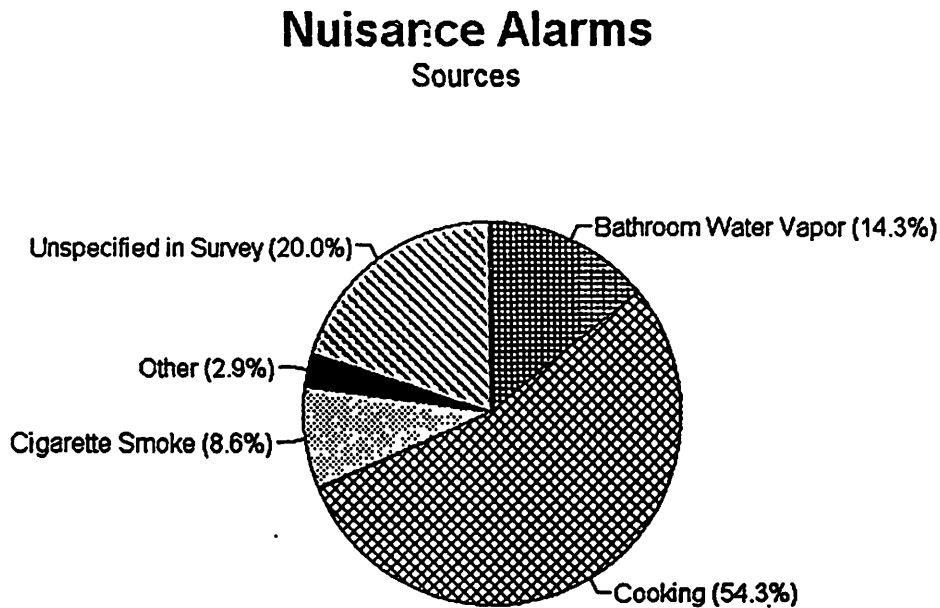
The Smoke Detector Operability Survey showed that many of the detectors in consumers' homes sounded due to cooking smoke, bathroom water vapors, tobacco smoke and other non-threatening sources of air-suspended particulate. Thirty-three detectors were collected and sent to the Laboratory for examination because the consumer believed there was a problem with the detector. In 32 of the detectors collected, the power had been disconnected by the consumer because of nuisance alarms. Figure 5 shows a breakdown of the sources of nuisance in the respondents' homes.

Figure 5. Sources of Nuisance Alarms from Collected Samples (n=33).

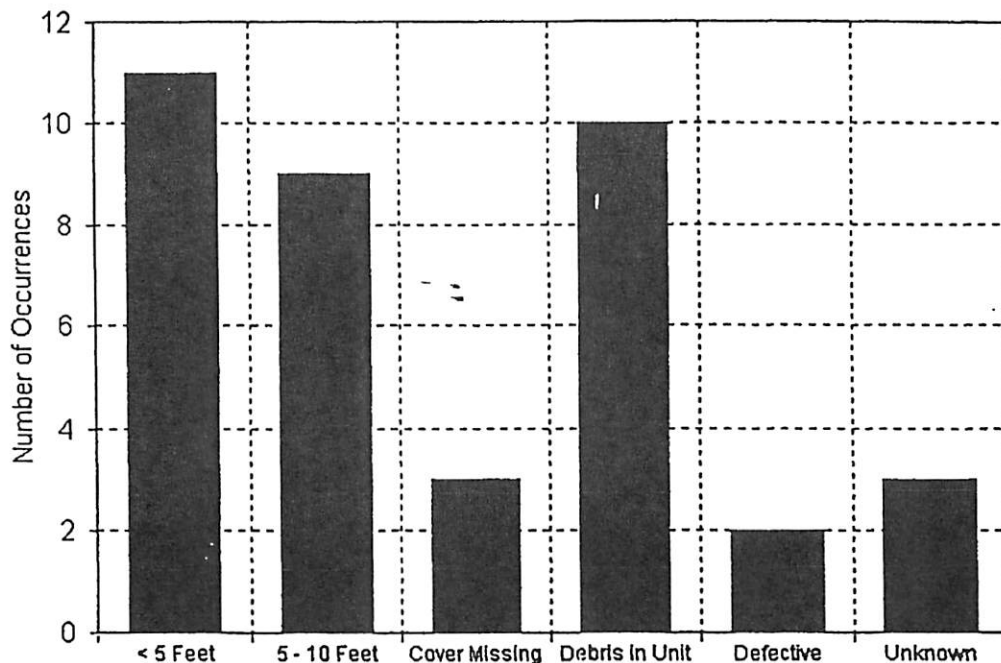
In Figure 6, the causes for frequent nuisance alarming were divided into categories determined by evaluating the smoke detectors in the Laboratory. The evaluation included reviewing the questionnaire survey responses, making visual observations of the units and testing the smoke detectors in the UL 217 Sensitivity Testing Chamber. Some units fell into more than one category. For example, one detector in which the "toaster set it off every morning," was located in the kitchen three feet from the toaster. The Sensitivity Test showed that this detector was highly sensitive, 0.66% ob/ft (2.15% ob/m). A combination of the location and the extreme sensitivity of the detector contributed to the frequent occurrence of nuisance alarms.

**Figure 6.** Reasons for Nuisance Alarms for Samples Collected (n=33).  
(Smoke Detectors were collected for multiple reasons causing the total to be greater than 33.)

The proper installation of the detector is important and can affect the sensitivity of the detector. In this Survey, questions about the placement of detectors were answered. Many of the collected detectors were in poorly chosen locations near kitchens, bathrooms and air ducts. Eleven of the 33 detectors were placed less than

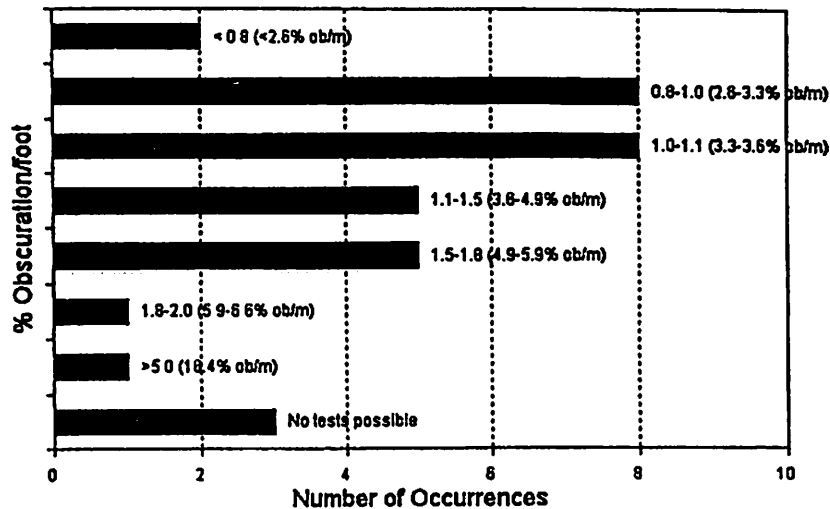
The detectors collected in the Survey were placed in the UL 217 Sensitivity Test Chamber to determine at what smoke obscuration level the detector responded. Three units collected for excessive nuisance alarming could not be tested in the UL 217 Sensitivity Test Chamber because of various malfunctions in the detector. The remaining 30 smoke detectors' sensitivity values are displayed in Figure 8. Further discussion on the sensitivity issue appears in the "Discussion" section of this report.

Figure 8. Sensitivity Levels of Smoke Detectors collected for Nuisance Alarming (n=33).

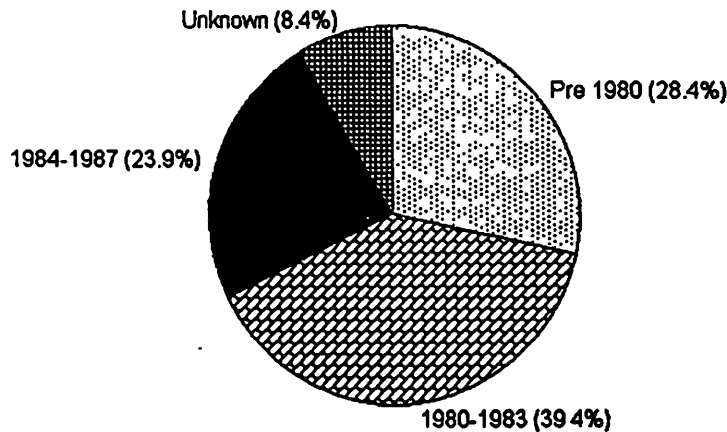
Figure 10 shows that detectors collected in the Survey have UL Release Dates prior to 1987. This information suggests that newly manufactured smoke detectors are much less likely to malfunction or have excessive nuisance alarms. Over time the detector's components can malfunction and their sensitivity can be altered by the household environment.

Figure 10. UL Release Date of Detectors Collected as Inoperable (n=155).
